DEPARTMENT OF TRANSPORTATION

Contract #: 04-0120F4Cty: SF/ALA Rte: 80 PM: 13.2/13.9File #: 69.28**WELDING INSPECTION REPORT****Resident Engineer:** Siegenthaler, Peter**Address:** 333 Burma Road**City:** Oakland, CA 94607**Report No:** WIR-020654**Date Inspected:** 15-Feb-2011**Project Name:** SAS Superstructure**OSM Arrival Time:** 700**Prime Contractor:** American Bridge/Fluor Enterprises, a JV**OSM Departure Time:** 1900**Contractor:** Zhenhua Port Machinery Company, Ltd (ZPMC), Changxing Island **Location:** Shanghai, China**CWI Name:** Shi Zhi**CWI Present:** Yes No**Inspected CWI report:** Yes No N/A**Rod Oven in Use:** Yes No N/A**Electrode to specification:** Yes No N/A**Weld Procedures Followed:** Yes No N/A**Qualified Welders:** Yes No N/A**Verified Joint Fit-up:** Yes No N/A**Approved Drawings:** Yes No N/A**Approved WPS:** Yes No N/A**Delayed / Cancelled:** Yes No N/A**Bridge No:** 34-0006**Component:** OBG**Summary of Items Observed:**

WELDING INSPECTION REPORT

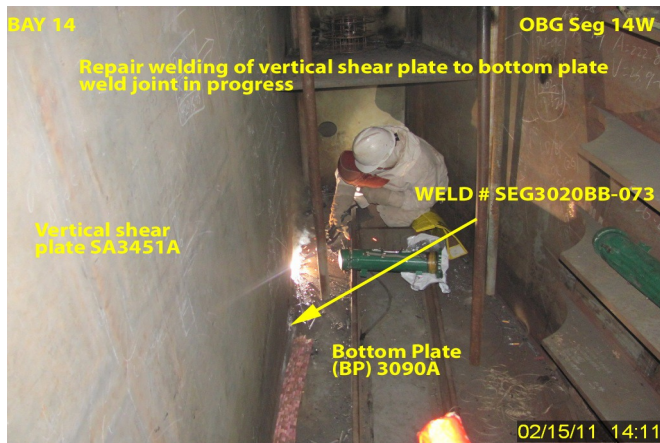
Repair welding of weld joint no: SEG3020BB-073 [Bottom Plate (BP) 3090A to Vertical Shear Plate SA3451A, Complete Joint Penetration (CJP) weld in between panel point (PP) 125~126]. The welder is identified as 067942 and was observed welding in the 2G position. Welding process was identified as Shielded Metal Arc Welding (SMAW). AB/F QA was identified as Mr. Xiao Jun Peng. The welding variables recorded by this QA appeared to comply with WPS: 345-SMAW-2G(2F)-FCM-Repair-1. Repair welding was done as per Critical Welding Repair (CWR) Report: B-CWR 2752 Rev-1. (Attached photograph provide additional details).
